Re: SITE HAZARD ASSESSMENT: Facility Site ID 73953138

Weyerhaeuser Snoqualmie Mill 38800 SE Mill Pond Rd

The Washington State Department of Ecology (Ecology) is writing to inform you that the above referenced property was subject to a site hazard assessment (SHA) as required under the Model Toxics Control Act, on 8/20/2021. The site was determined to be contaminated with petroleum hydrocarbons, PCBs, PAHs, and phenols. The site's hazard ranking, an estimation of the potential threat to human health and/or the environment relative to all other Washington state sites assessed at this time, has been determined by Ecology to be a 1, where a 1 represents the highest relative risk and 5 the lowest.

SITE NAME: Weyerhaeuser Snoqualmie Mill

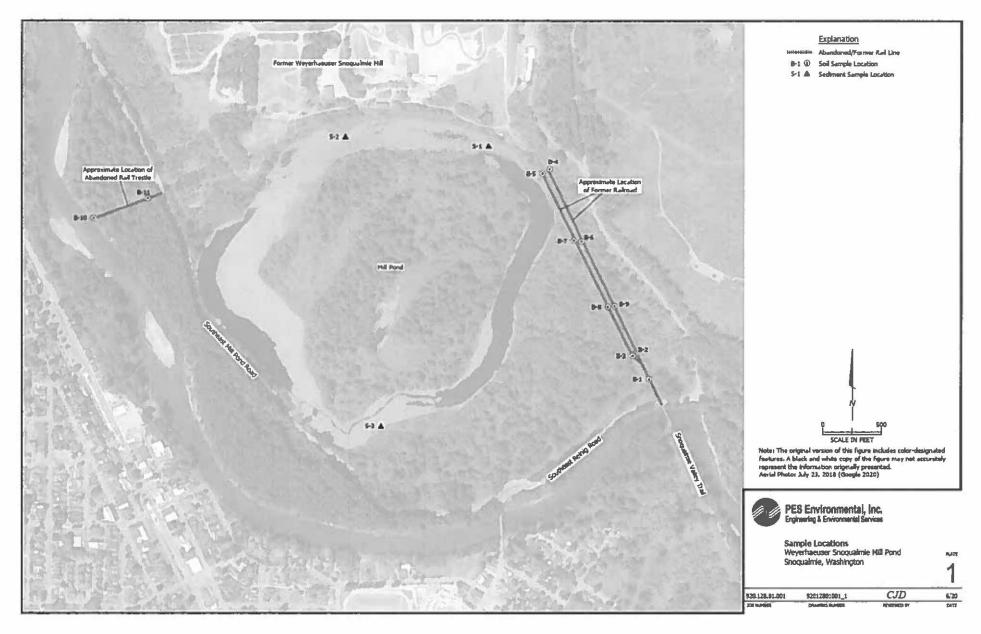
FIGURE 4. Sediment and soil sampling locations. Sediment locations are approximately the same as where Ecology collected samples in 1993. Figure from PES Environmental (2020) Sediment and Soil Sampling Summary.

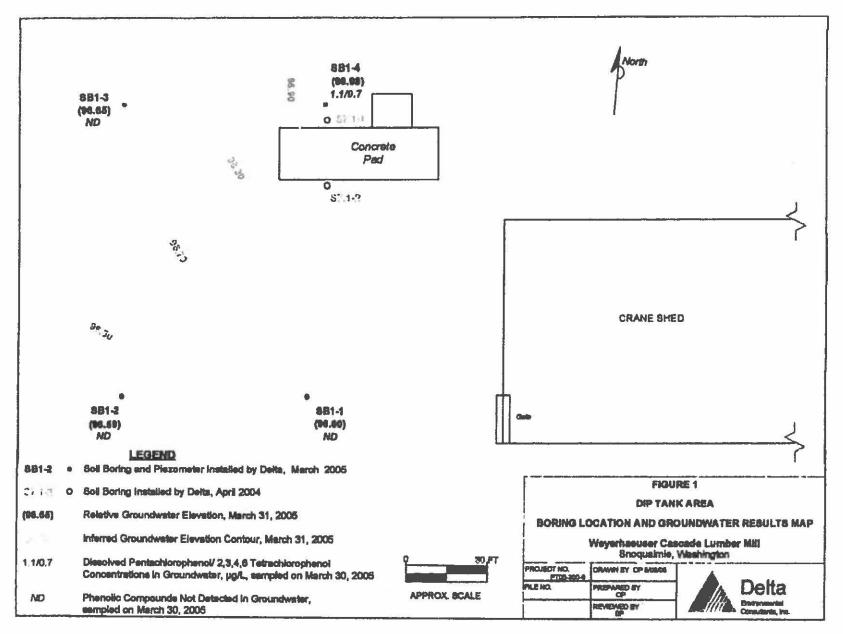
FIGURE 5. Sampling locations in Dip Tank Area 1. Figure from Delta (2005) Supplemental ESA for Former Lumber Strapping Area and Former Dip Tank Area.

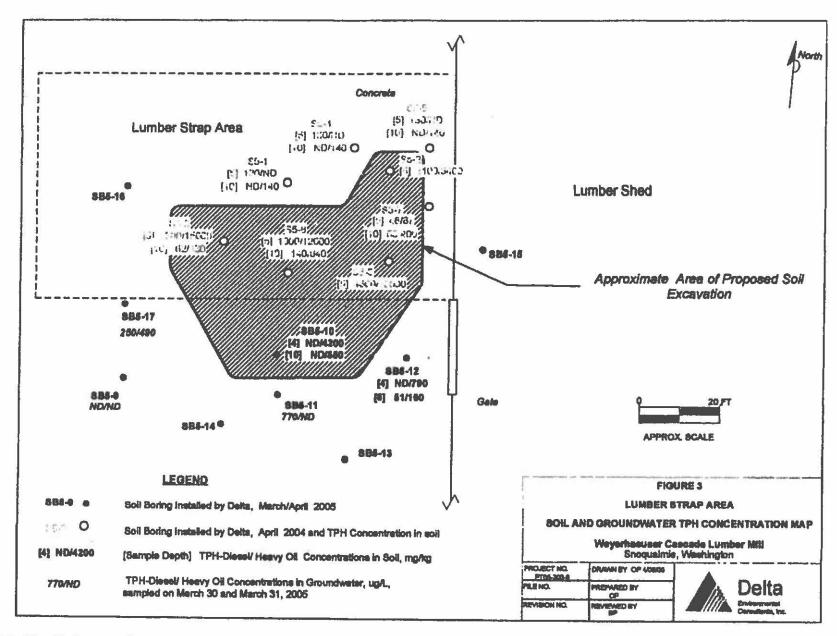
The lumber strapping area was located on the west side of the shipping building, in the northern portion of the mill. Strapping is the step in the packaging process where lumber is bundled together prior to shipping. The source of contamination in this area is likely a hydraulic oil leak from the strapping equipment. A soil sample collected from this area during the 2004 Level II ESA confirmed contamination with TPH-Dx. Additional soil and

FIGURE 6. Identified extent of contaminated soil in the Lumber Strapping Area prior to the 2005 excavation. Figure from Delta (2005) Supplemental ESA for Former Lumber Strapping Area and Former Dip Tank Area.

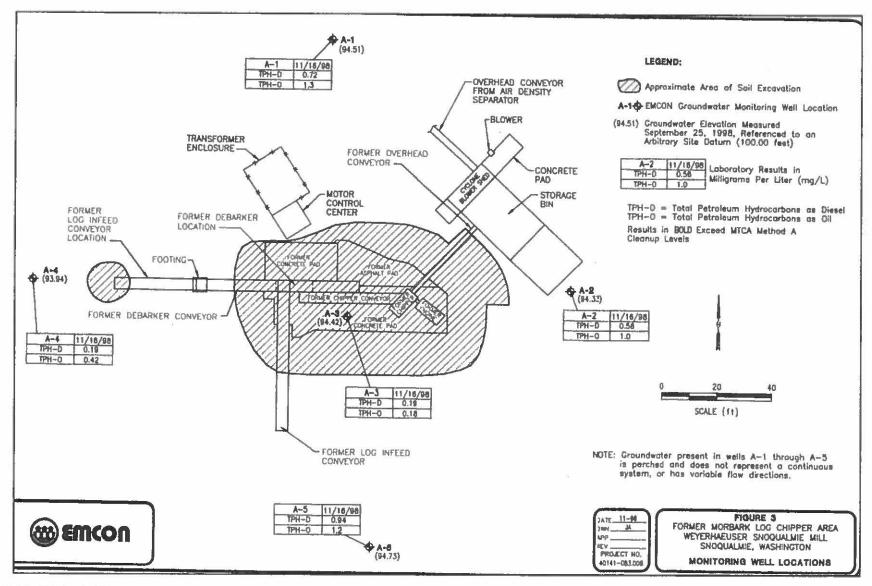
Log chipping operations began in this area of the Site in the late 1960s. The Morbark chipping machinery included a conveyer that fed logs into a debarker and chipper. The machinery was originally powered by diesel engines, but was converted to electric power in 1976. A new debarker was installed in 1993. Chipping operations at the Site ended in September 1997, and the chipping machinery was removed in 1998. There were multiple features of normal operations of the machinery that may have contributed to contamination in this area, including a leak of hydraulic oil from the original debarker before its replacement in 1993, lubrication of chains by pouring 5 gallon buckets of oil directly on them, and washing of spilled oil off of the asphalt pad onto the ground to the south and southwest of the chipper machinery.

FIGURE 7. Morbark Chipper area, showing groundwater concentrations of TPH-Dx and areas of 1998 soil excavation. Additional soil removal in this area was done as part of the 2005 excavations, but based on available information in the site file, the location of that excavation is unknown. Note: the sum of TPH-D and TPH-O should be used for comparison to the cleanup level (current Method A is 0.5 mg/L). Figure from Emcon (1998) Remedial Action Report, Former Morbark Chipper Area.

Remediation was done by Emcon in 1998, after removal of the machinery. This included removal of the concrete foundation and asphalt pad that the machinery had been located on. The area of soil to be excavated was determined using a site-specific total TPH action level of 4400 mg/kg. Approximately 1386 tons of contaminated soil was removed from two areas (Figure 7) near the former machinery. The western excavation, near the infeed conveyor, extended to a depth of 6 feet bgs. No groundwater was encountered in this excavation, and post-excavation confirmation samples were collected from the sidewalls and base of the excavation. The excavation in the debarker and chipper area extended to approximately 5 feet bgs, the depth at which groundwater was encountered. Due to the presence of groundwater, no base of excavation confirmation sample was collected. Following the initial excavations, only sample SW-5 contained TPH above the action level. Two additional excavations occurred in this area. Excavations stopped when they reached the adjacent storage bin building. The confirmation sample collected after the final excavation, sample SW-5-2, contained TPH above the action level.

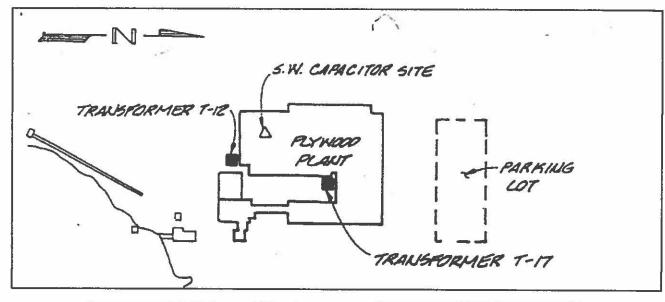
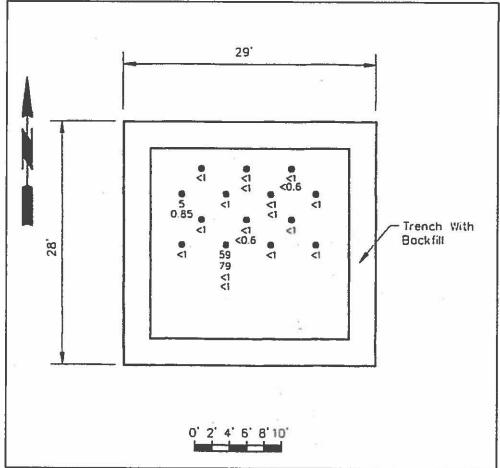
A fire on February 5, 1989 destroyed the plywood plant. During the fire, falling debris damaged two transformers (Transformer 12 and Transformer 17; see Figure 8). Both transformers were filled with PCB-containing askarel fluid, which leaked into the surrounding soil as a result of the damage sustained during the fire. Investigations into the extent of PCB contamination in soil and groundwater were conducted in February-April 1989 by HDR Engineering and Weyerhaeuser. Excavation of contaminated soil was done in June 1989.

FIGURE 8. Location of transformers T-17 and T-12 within the plywood plant (top). Soil concentrations of PCBs in the T-17 excavation area following remedial actions (bottom). Locations with 2 concentrations indicate locations where duplicate samples were collected. The location with 4 values indicates a sample and duplicate with concentrations above the above the target PCB concentration; an additional 6 inches of soil was excavated in this area, and then another excavation base sample and duplicate were collected in this location. Figures from HDR Engineering (1990) Plywood Plant Fire Site... Cleanup Summaries, Risk Assessment, and Site Hazard Ranking Report.

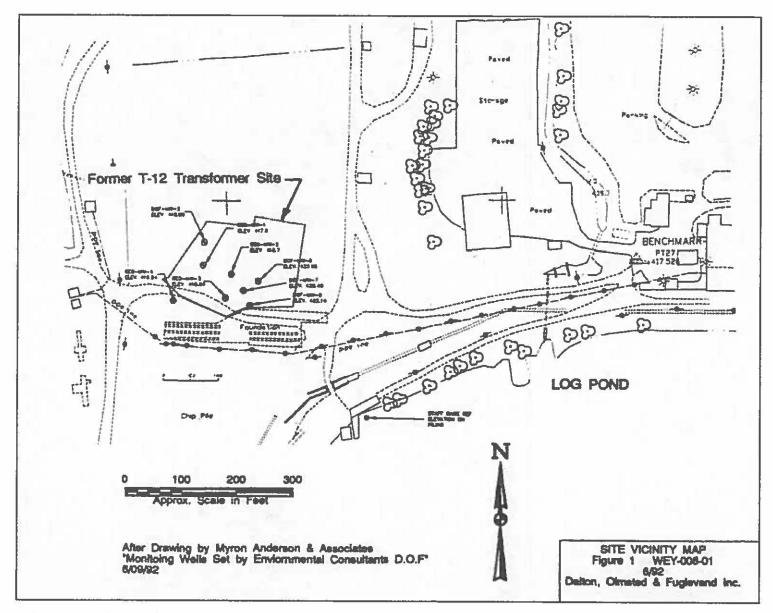
FIGURE 9. Approximate area of geotextile liner installed around T-12 indicated by Former T-12 Transformer Site boundary. The T-12 soil excavation was a smaller area around location MW-2 on the figure. Figure from Dalton, Olmsted, & Fuglevand (1994) Additional Assessment of PCB Contamination, T-12 Area.

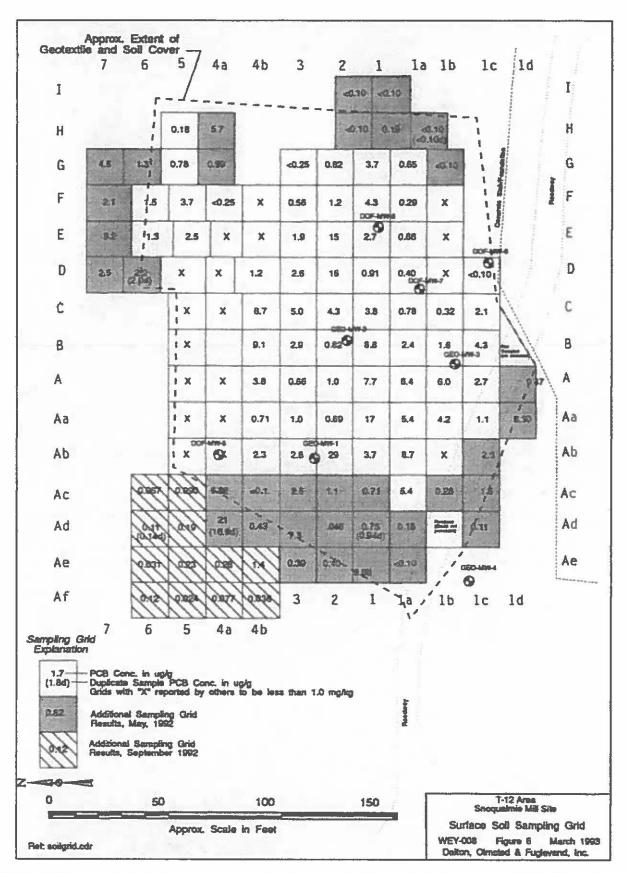
FIGURE 10. PCB concentrations in near-surface soil under and near the geotextile barrier near T-12. Figure from Dalton, Olmsted, & Fuglevand (1994) Additional Assessment of PCB Contamination, T-12 Area.

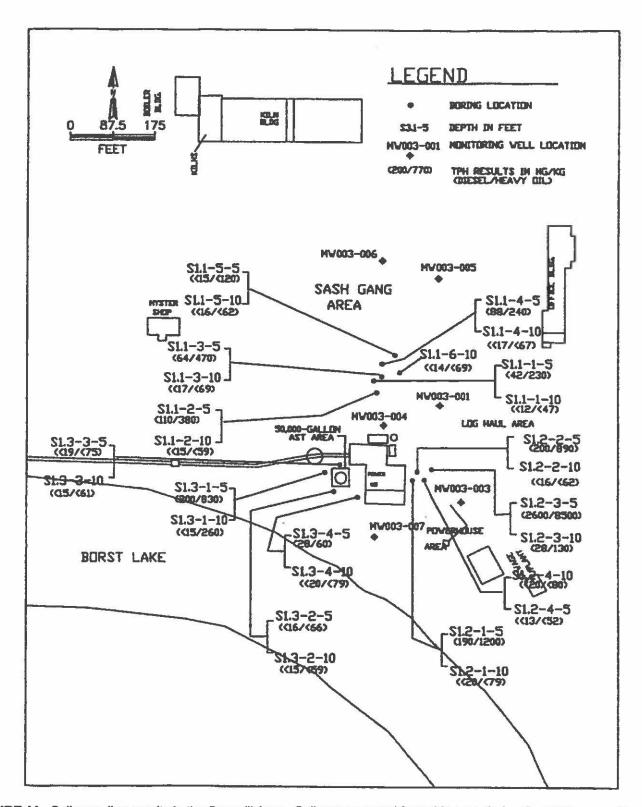
FIGURE 11. Soil sampling results in the Sawmill Area. Soil was removed from this area during the 2005 excavations, but the location of the excavation cannot be determined from the information available in the site file. Figure from Delta (2004) Level III ESA.

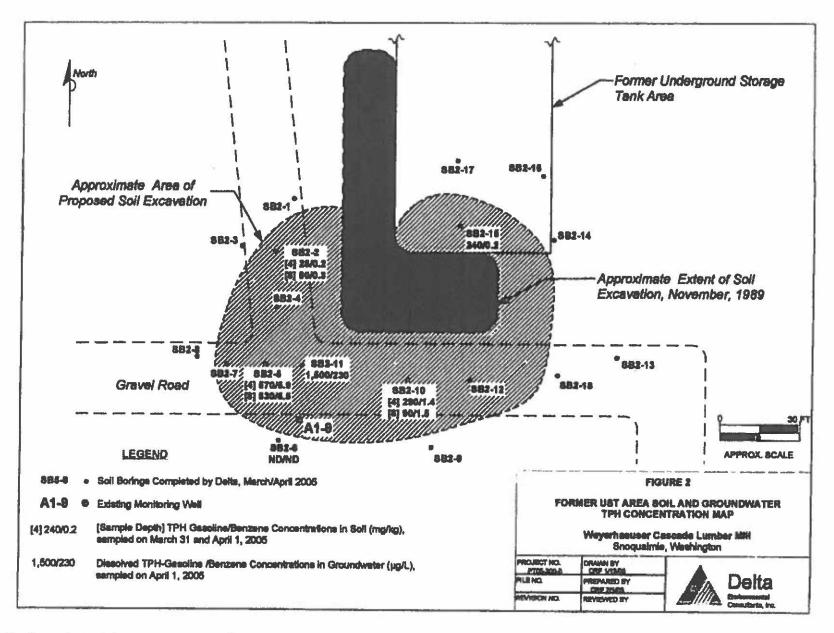
FIGURE 12. Area of remaining contaminated soil in the UST Area as of 2005. Additional soil removal was done in this area as part of the 2005 excavations, but the extent of that excavation cannot be determined from the available information in the site file. Figure from Delta (2005) Supplemental ESA for Former UST/AST Area.

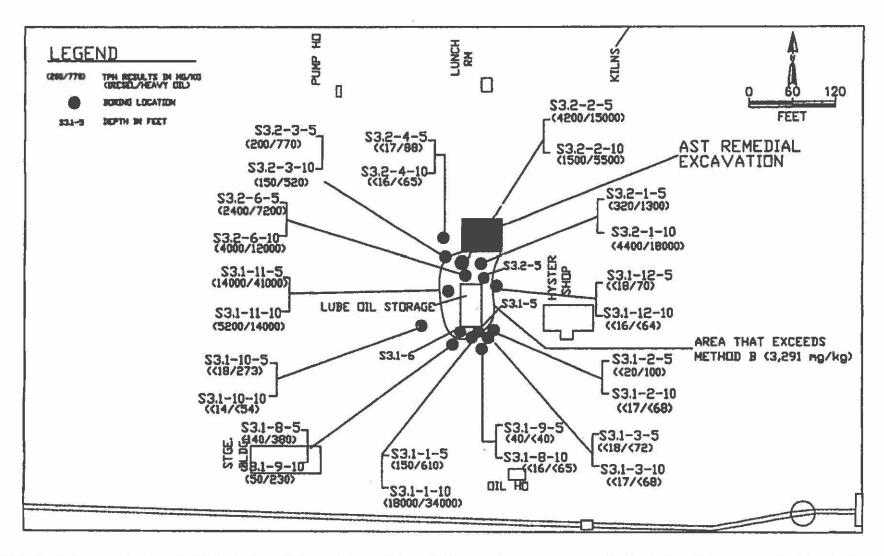
Delta also conducted additional sampling in the AST area as part of the 2004 Level III ESA. Soil samples were collected from near the previous AST excavation area, as well as around the adjacent fuel oil storage building. Soil concentrations of TPH-Dx were elevated in an area extending south of the previous excavation (Figure 13). Free product was observed in some borings. A groundwater sample collected from boring S-3.1 contained TPH-Dx above the Method A cleanup level.

FIGURE 13. Soil concentrations of TPH-Dx in the AST Area. Indicated Remedial Excavation boundaries are for the 1989 soil excavation. Additional soil excavation in this area was done as part of the 2005 excavations, but the area of excavation cannot be determined from the information available in the site file. Figure from Delta (2004) Level III ESA.

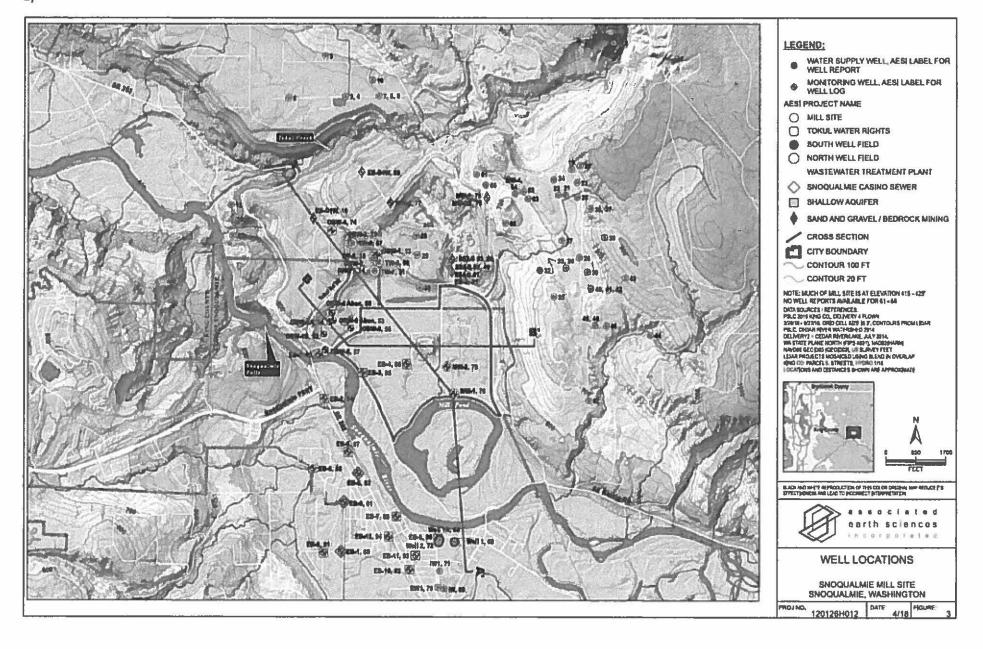
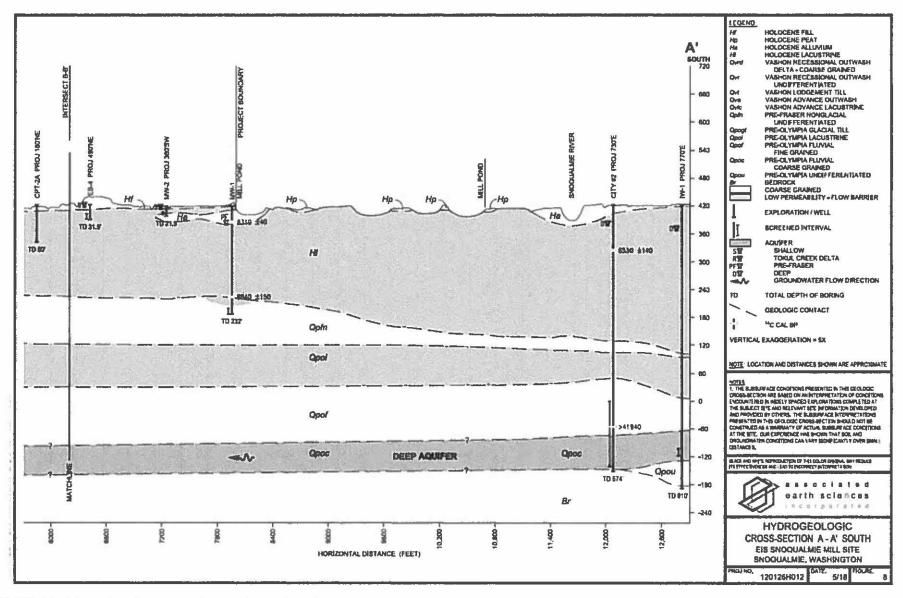
FIGURE 14. a) Location of cross-section and b) portion of cross-section A-A' that covers the south end of the former mill, where groundwater contamination has been previously documented on Site. The deepest documented groundwater contamination on Site is in the Shallow aquifer. MW-1, completed in the Pre-Fraser aquifer on the south end of the mill property, provides information on the extent of low permeability soil separating the two aquifers. Figures from Associated Earth Sciences (2020) Soil, Geology, Groundwater and Geologic Hazards Report.

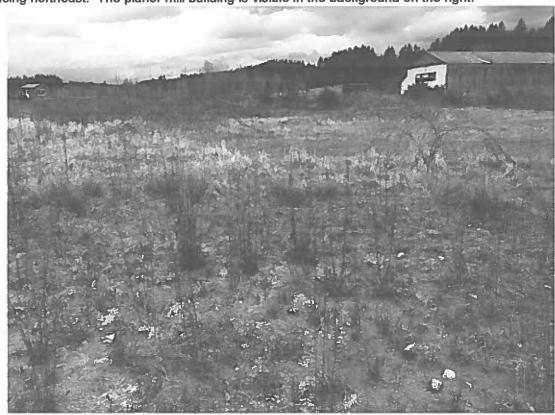
c) UST area, facing northeast. The planer mill building is visible in the background on the right.

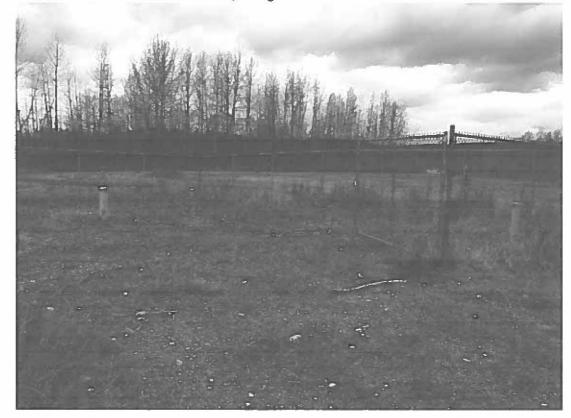
d) North end of the fenced-off PCB area around T-12, facing northwest.

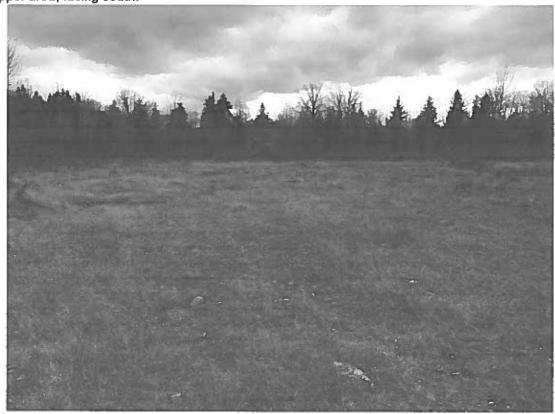
a) Morbark Chipper area, facing south.

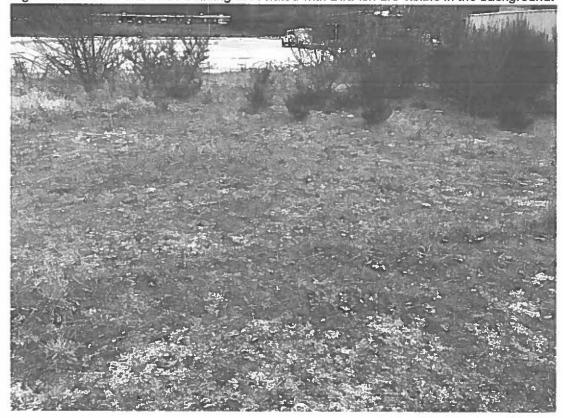
b) AST area, facing east. Vehicles and office building associated with DirtFish are visible in the background.

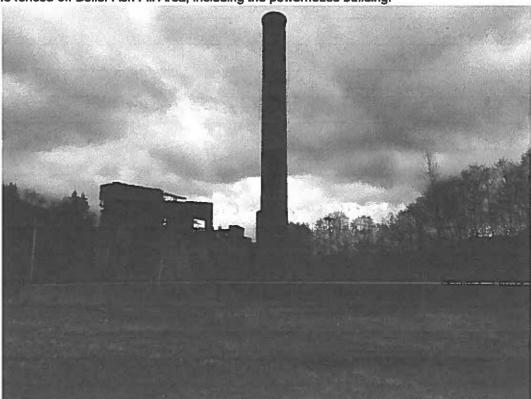
e) East end of the fenced-off Boiler Ash Fill Area, including the powerhouse building.

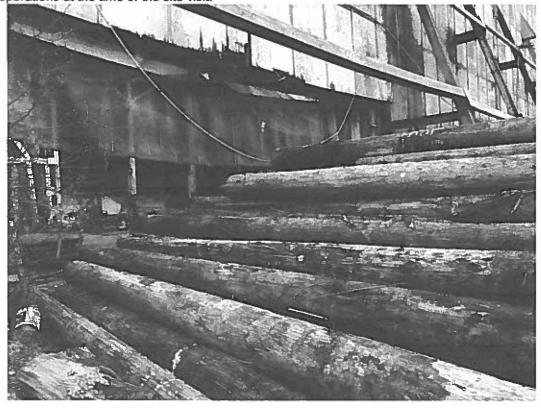
f) South portion of the Lumber Strapping Area, facing southeast. The area was being used for log storage as part of commercial operations at the time of the site visit.

FIGURE 15. Photos taken by the Assessor during the April 2021 site visit. Many of the areas of contamination are currently open vegetated spaces, including the a) Morbark Chipper, b) AST Area, and c) UST Area. Fencing is in place to limit access to the d) T-12 Area and e) Boiler Ash Fill Area. The f) Lumber Strapping Area is within the portion of the site currently used for commercial activities, specifically the area used by Merrill & Ring lumber company.
